Number
National Dam Inspection Program, Crystal Lake Dam (NDS ID#562), Susquehanna River Basin, Wapwallopen Creek, Luzerne County, Pennsylvania, Phase I Inspection Report.

CRYSTAL LAKE DAM

PHASE I INSPECTION REPORT

⑪ MAY 1978

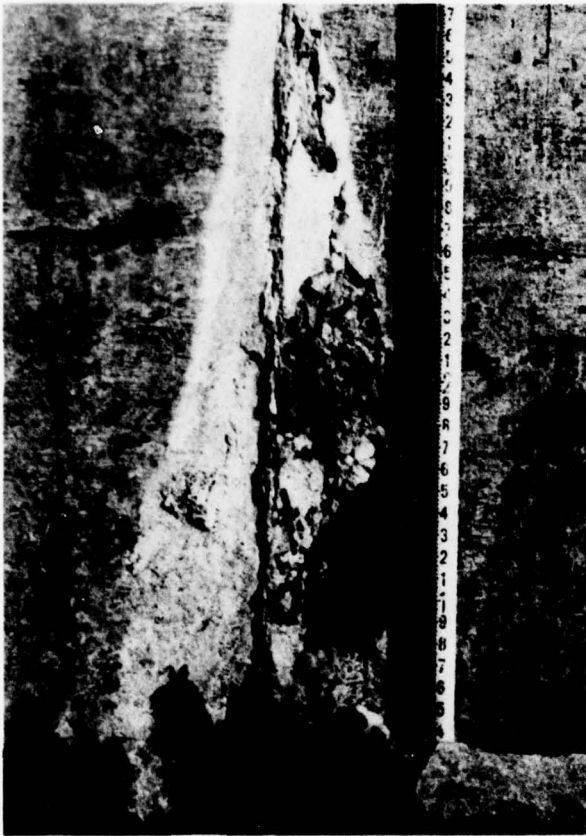
G. Downstream Face of Main Spillway
Showing Deteriorating Concrete

(5) Visually monitor the seepage and deteriorating concrete at the contraction joints and take remedial action as required.

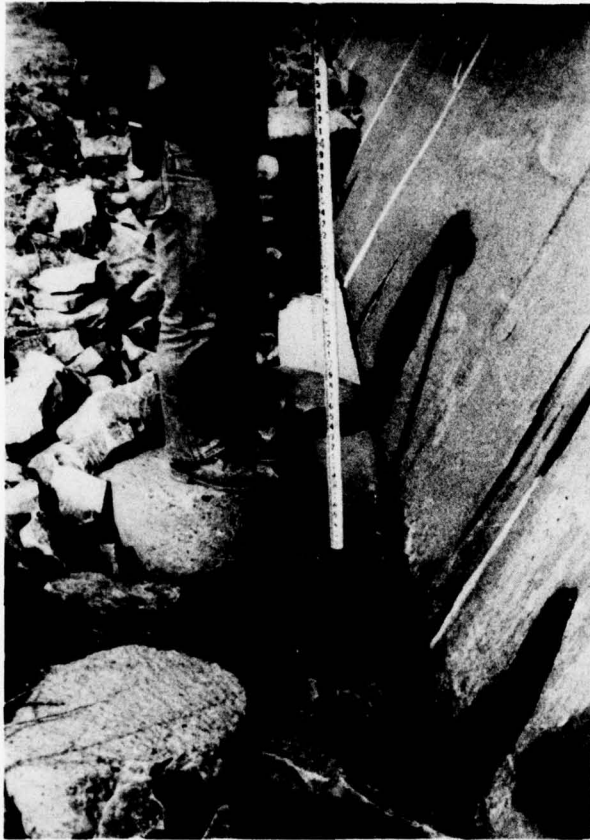
I. Water at the Toe
of the Main Spillway

(6) Visually monitor the seepage from the foundation and take appropriate action as necessary.

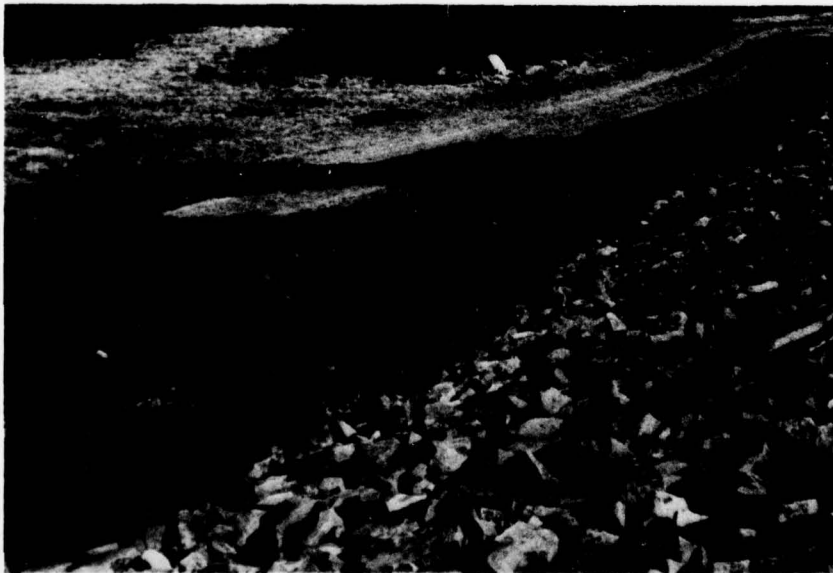
(2) Dikes. Standing water at the toes of the dikes, standing water and wet areas downstream of the left abutment dike, and the rutted surface of the top of south dike, have been observed. The detailed description and evaluation of these conditions are in Paragraphs 3.1.b. and 3.2.a., respectively.

J. Wet Area at the Toe
of the Left Abutment Dike

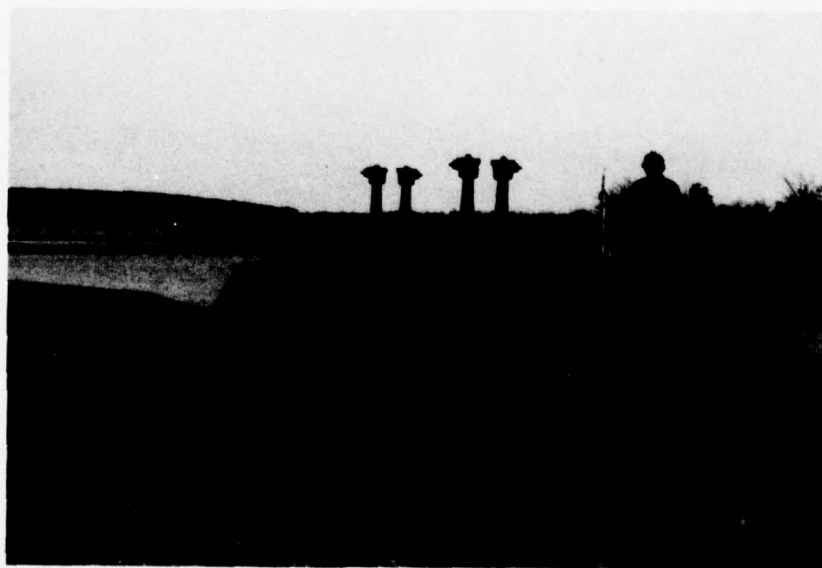
d. Appurtenant Structures. No defects were noted in the active intake structure. The abandoned gate structure (Photograph L) also appeared in excellent condition. The Owner reported that the area immediately downstream of the gate structure was backfilled with rock. He also stated that the gates had a protective coating applied to them before the backfill was placed. The operating of the valve on the 6-inch diameter blowoff line (Photograph B) was not observed. The Owner stated that this blowoff was intended to remove sediment from the water supply lines and would be incapable of drawing down the reservoir. He stated that the water supply lines could be used as emergency drawdown lines.

L. Abandoned Water Supply Gate Structure
and Nonoverflow Section at Right

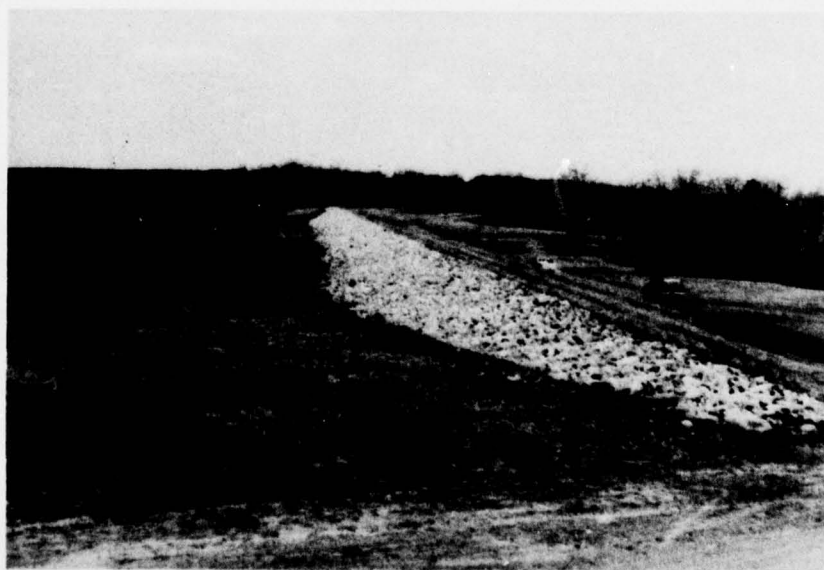
b. Dikes. The left abutment dike (Photograph K), south dike (Photograph M), southeast dike (Photograph N), and northeast dike (Photographs P and Q) appear in excellent condition. The sod is in good condition. No cracks, movement, or sloughing were noted on the dikes. The top of the south dike was rutted to a depth of about 8 inches. The Owner reports that, although the area is posted, trail bikes use the top of dike as a road. The riprap is in excellent condition with no signs of weathering or erosion. There is a noticeable difference in the gradation of the riprap in some areas. The stones in these areas are segregated into clusters of larger and smaller sizes. These clusters are neither large in area nor extreme in size of stone. Standing water was noted at the toes of the dikes. The left abutment dike had water standing at the downstream toe and extending from it for 15 feet downstream towards a gully (Photograph J). A wet area, about 100 square feet in size, was observed 40 feet downstream of the toe of the left abutment dike. This wet area was at the base of the hill that forms the abutment of the dike. The boots of inspectors walking over the wet area penetrated about 1 inch into the surface. No standing water was observed. There was no flow from the wet area nor from the pools of standing water at the toes of the dikes. Water was standing in many low areas of the unpaved roads in the vicinity. The right abutment dike (Photograph C) does not appear to be constructed in accordance with the plans supplied by the Owner. The dike is covered with rock, and the top of the dike is 2.5 feet lower than the plans indicate. Adjacent to the right overflow section, for a 15-foot length, the top of embankment is 1 foot lower than the nonoverflow section.

N. Southeast Dike
Crystal Lake Shown at Left

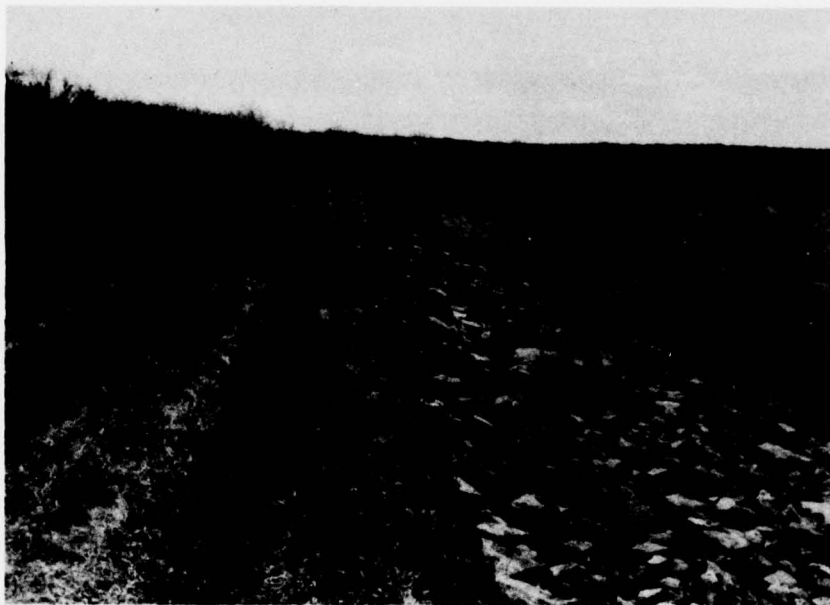
P. Northeast Dike
Crystal Lake Shown at Right
